5 WTC 7

5.1 Introduction

WTC 7 collapsed on September 11, 2001, at 5:20 p.m. There were no known casualties due to this collapse. The performance of WTC 7 is of significant interest because it appears the collapse was due primarily to fire, rather than any impact damage from the collapsing towers. Prior to September 11, 2001, there was little, if any, record of fire-induced collapse of large fire-protected steel buildings.

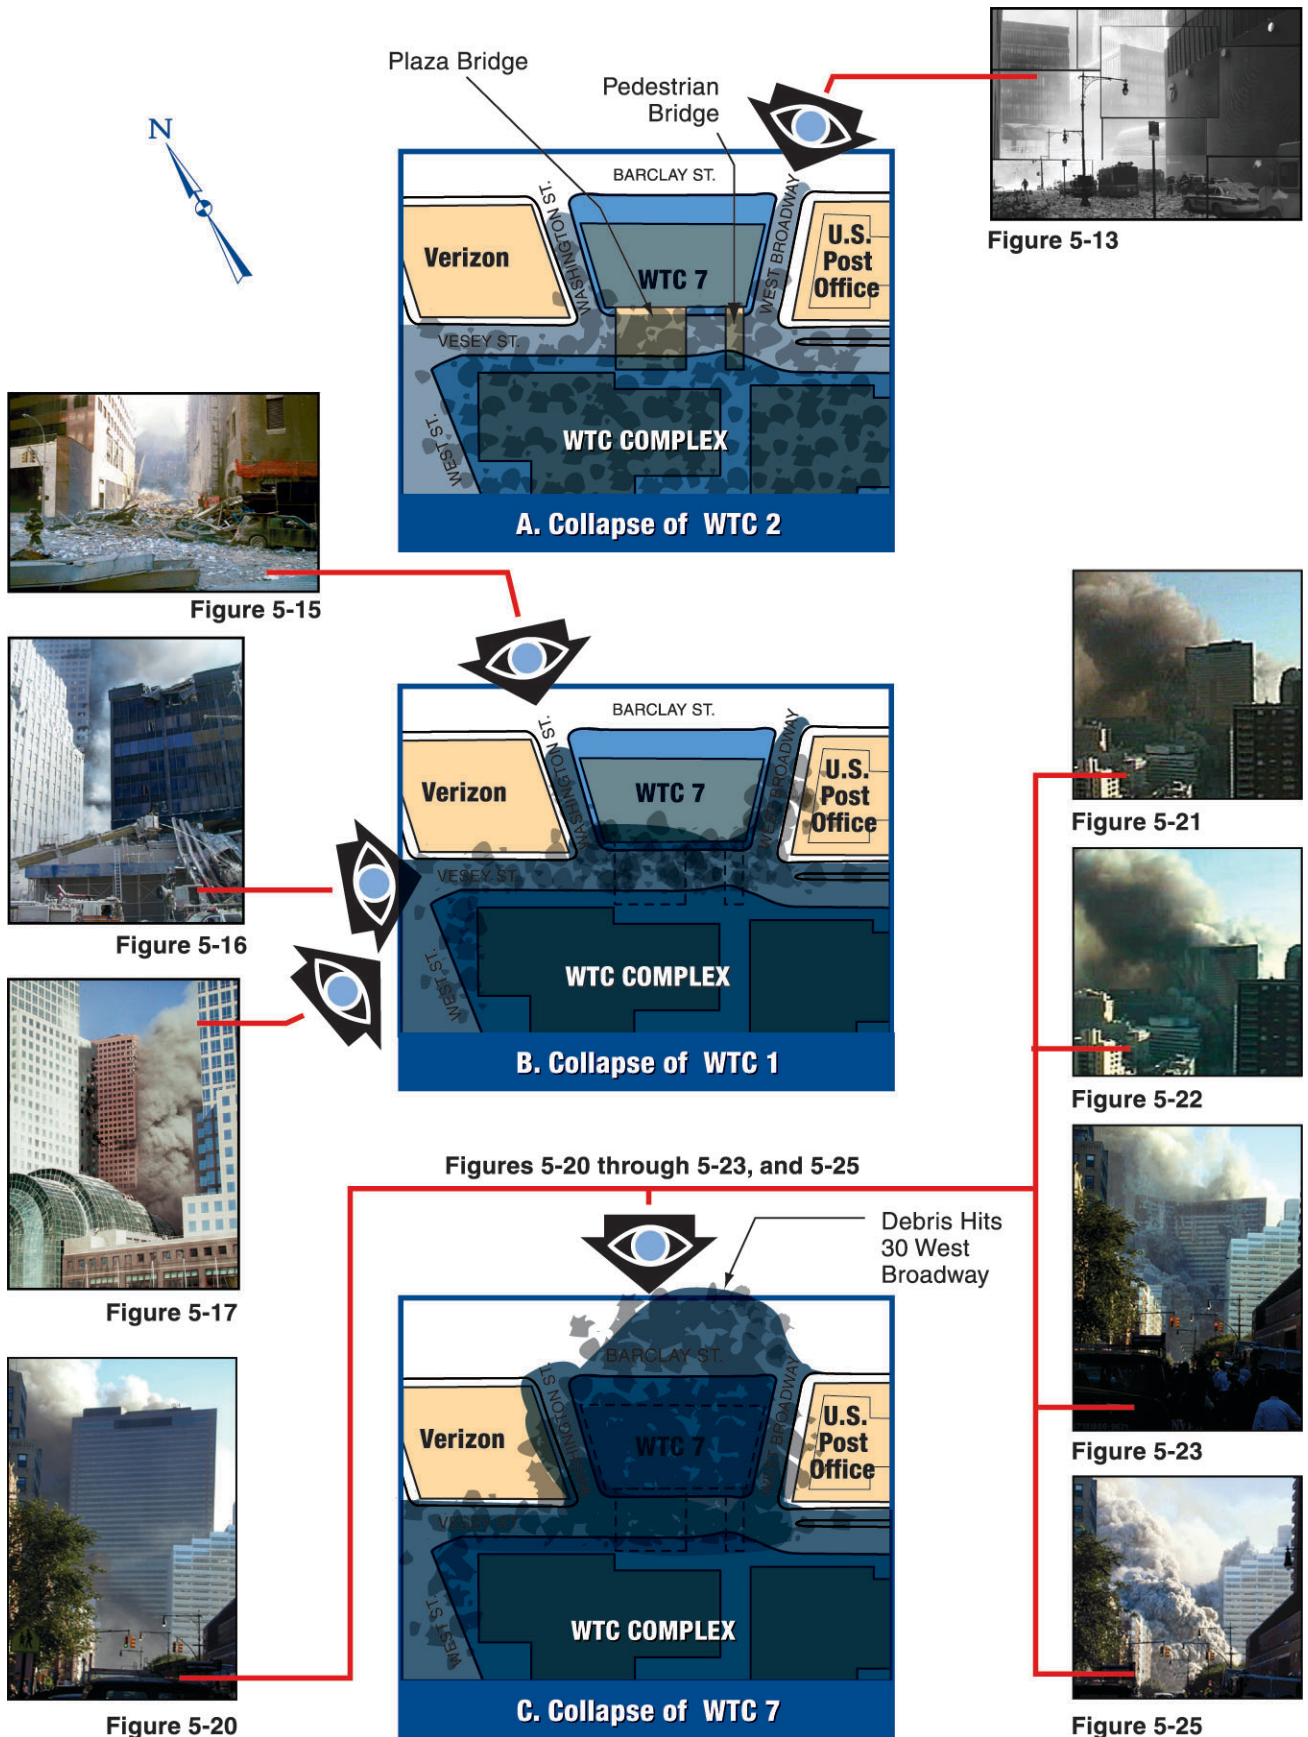
At 9:59 a.m., WTC 2 (the south tower) collapsed. The approximate extent of its debris is shown in Figure 5-12(A). It appears that the collapse of WTC 2 did not significantly affect the roof, or the east, west, and north elevations of WTC 7. It is unknown if there was any damage to the south elevation after WTC 2 collapsed, but both the covered, tubular pedestrian bridge (see Figure 5-13) and the Plaza bridge were still standing after the collapse of WTC 2.

Figure 5-12 Sequence of debris generated by collapses of WTC 2, 1, and 7.

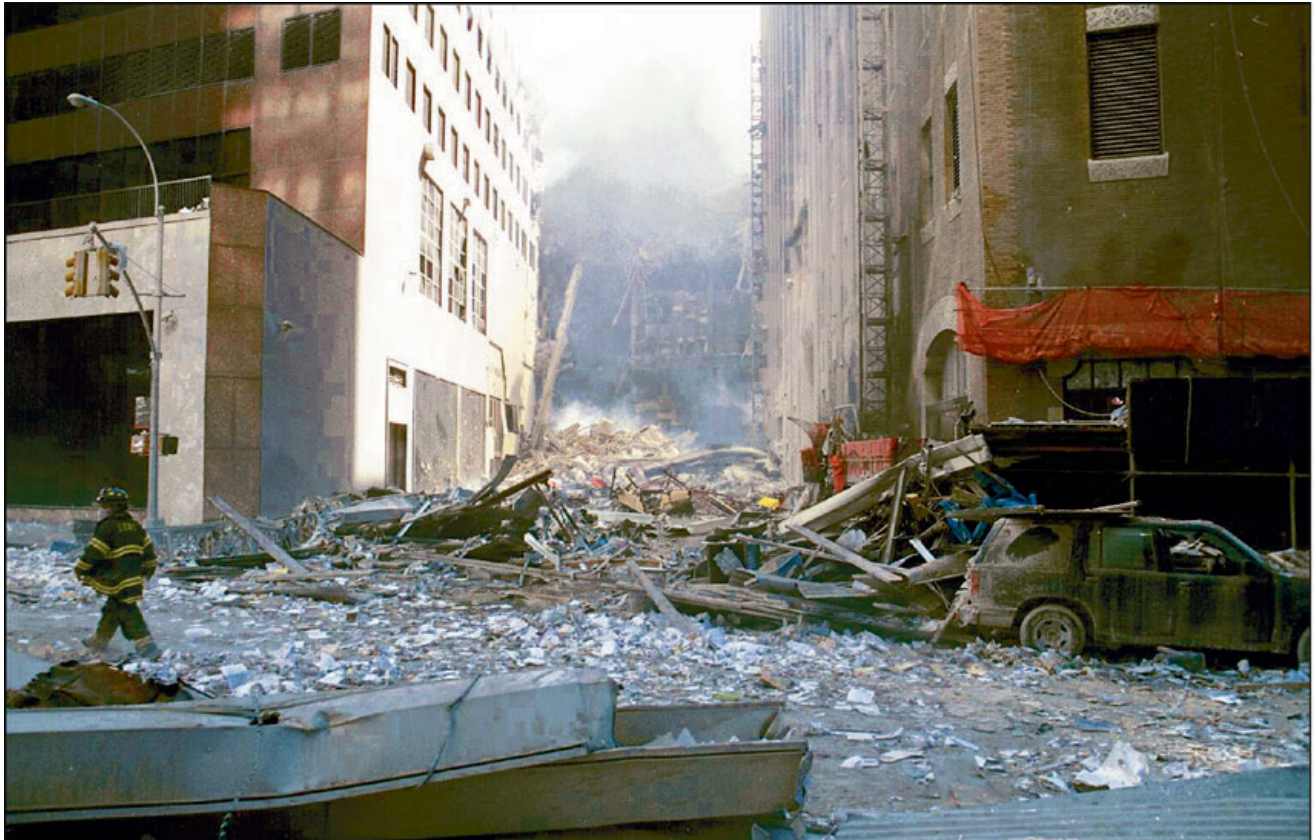
Figure 5-14 is an aerial photograph that shows the debris clouds spreading around WTC 7 just after the collapse of WTC 1. Figure 5-15 is a photograph of WTC 1 debris between the west elevation of WTC 7 and the Verizon building. Figure 5-12(B) shows a plan-view diagram approximating the extent of this debris just after the collapse of WTC 1.

Figure 5-15 Debris from the collapse of WTC 1 located between WTC 7 (left) and the Verizon building (right).

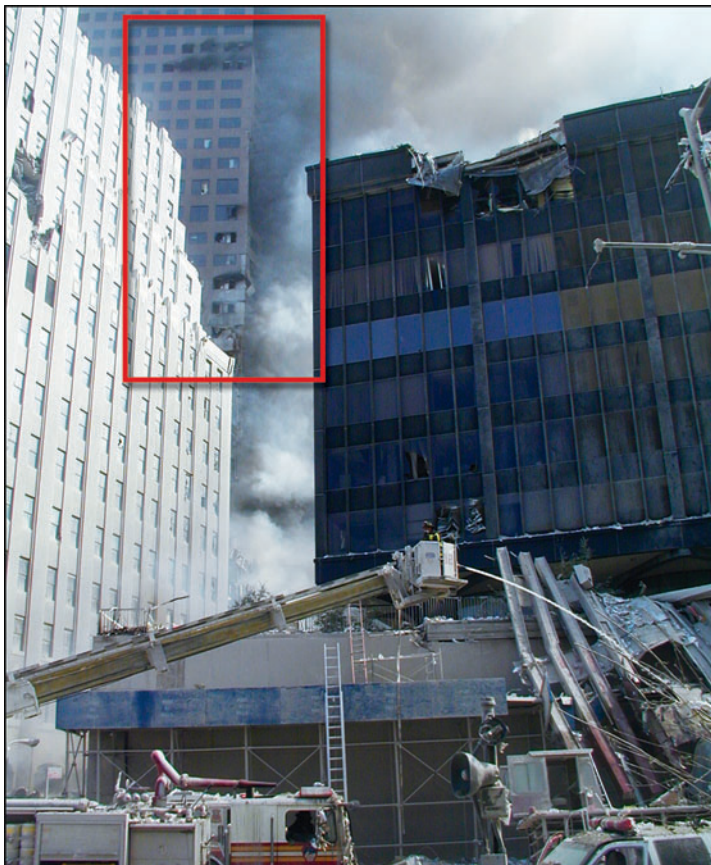
It does not appear that the collapse of WTC 1 affected the roof, or the east, west, and north elevations of WTC 7 in any significant way. However, there was damage to the southwest corner of WTC 7 at approximately floors 8 to 20, 24, 25, and 39 to 46, as shown in Figure 5-16, a photograph taken from West Street.

Figure 5-16 Damage to southwest corner of WTC 7 (see box), looking from West Street.

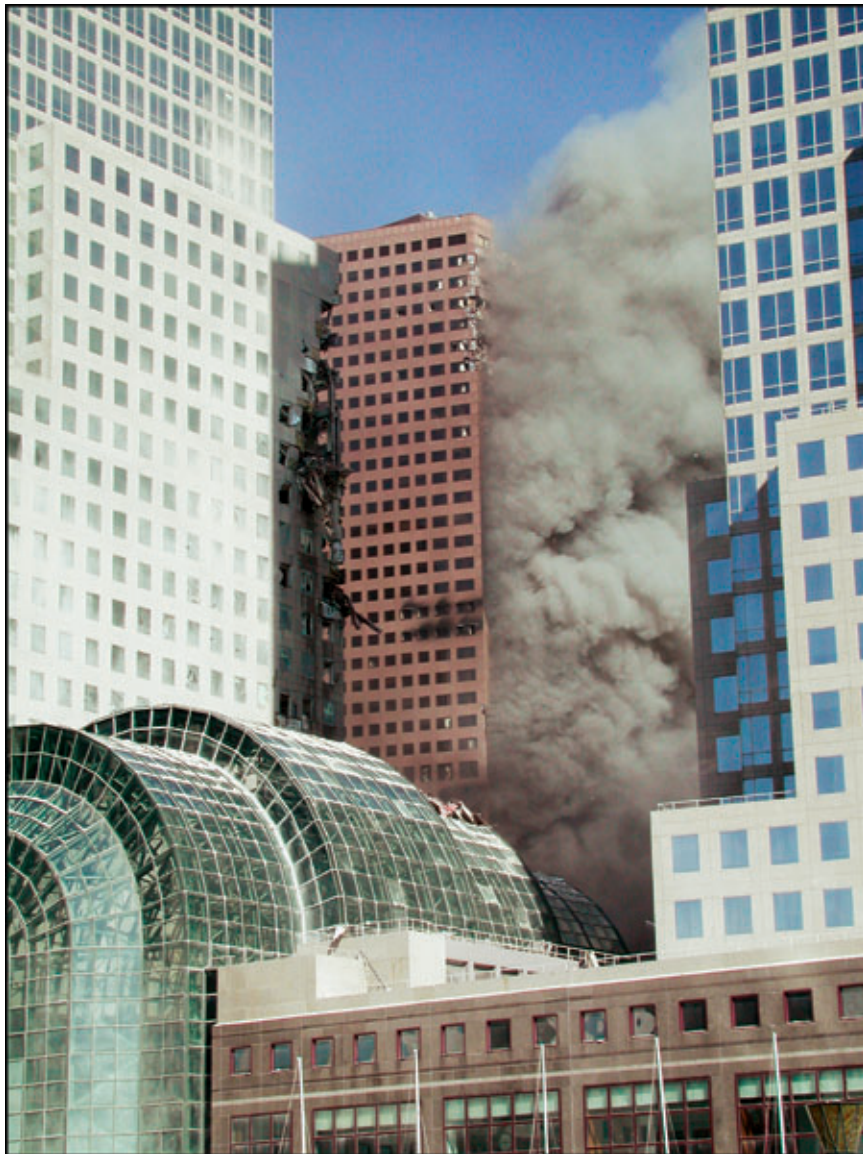
Figure 5-17, a photograph taken across from the World Financial Center (WFC), shows the west elevation and indicates damage at the southwest corner of WTC 7 at the 24th, 25th, and 39th through 46th floors.

*Figure 5-17
Building damage to the southwest corner and smoke plume from south face of WTC 7, looking from the World Financial Plaza. Note damage to WFC 3 in the foreground.*

Video footage indicated that the majority of the smoke appeared to be coming from the south side of the building at that time as opposed to the other sides of the building. This is corroborated by Figure 5-17, a photograph taken at 3:36 p.m. that shows the south face of WTC 7 covered with a thick cloud of smoke, and only small amounts of smoke emanating from the 27th and 28th floors of the west face of WTC 7.

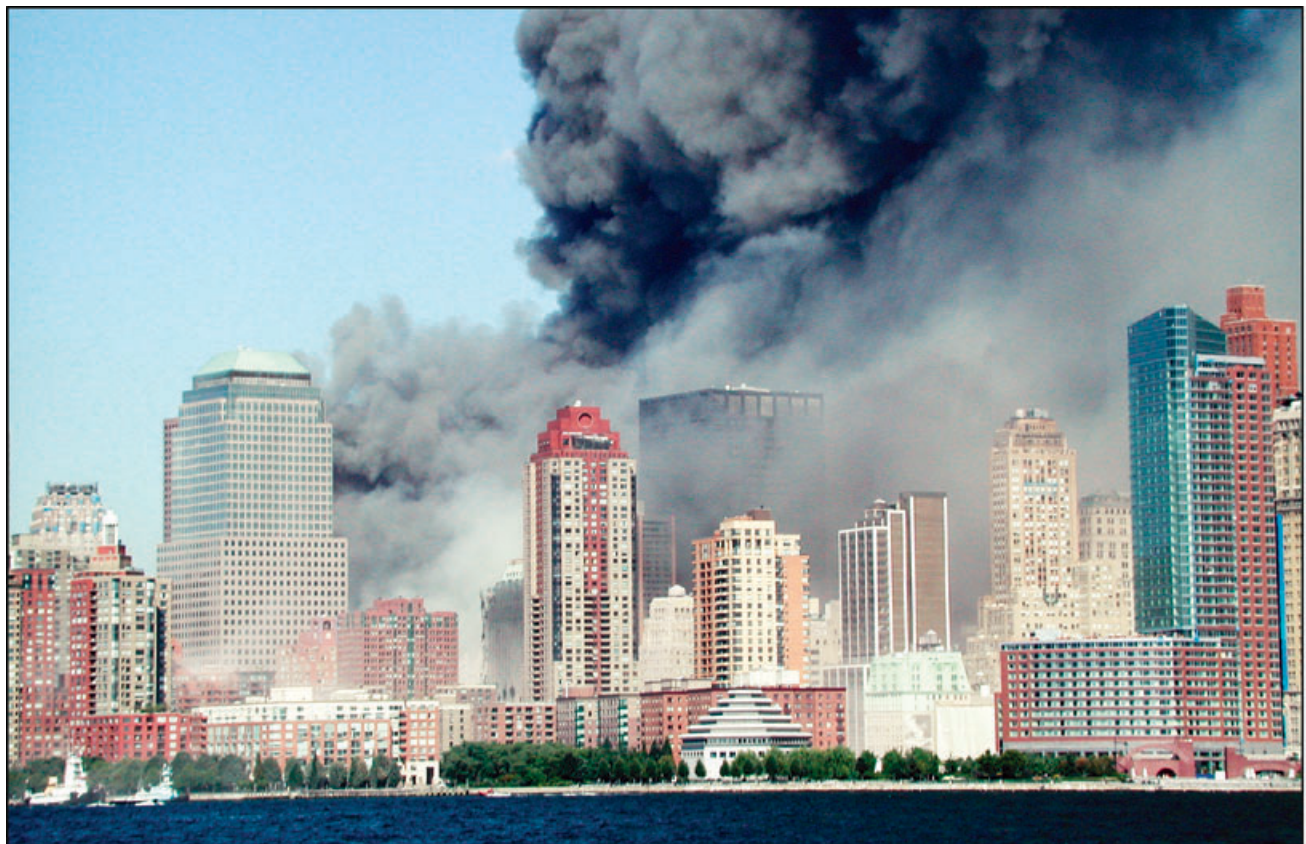
News coverage after 1:30 p.m. showed light-colored smoke flowing out of openings on the upper floors of the south side of the building. Another photograph (Figure 5-18) of the skyline at 3:25 p.m., taken from the southwest, shows a large volume of dark smoke coming from all but the lowest levels of WTC 7, where white smoke is emanating. The mode of fire and smoke spread was unclear; however, it may have been propagated through interior shafts, between floors along the south façade that may have been damaged, or other internal openings, as well as the floor slab/exterior façade connections.

Figure 5-18 WTC 7, with a large volume of dark smoke rising from it, just visible behind WFC 1 (left). A much smaller volume of white smoke is seen rising from the base of WTC 7. Note that the lower, lighter-colored smoke (to right) is thought to be from the two collapsed towers

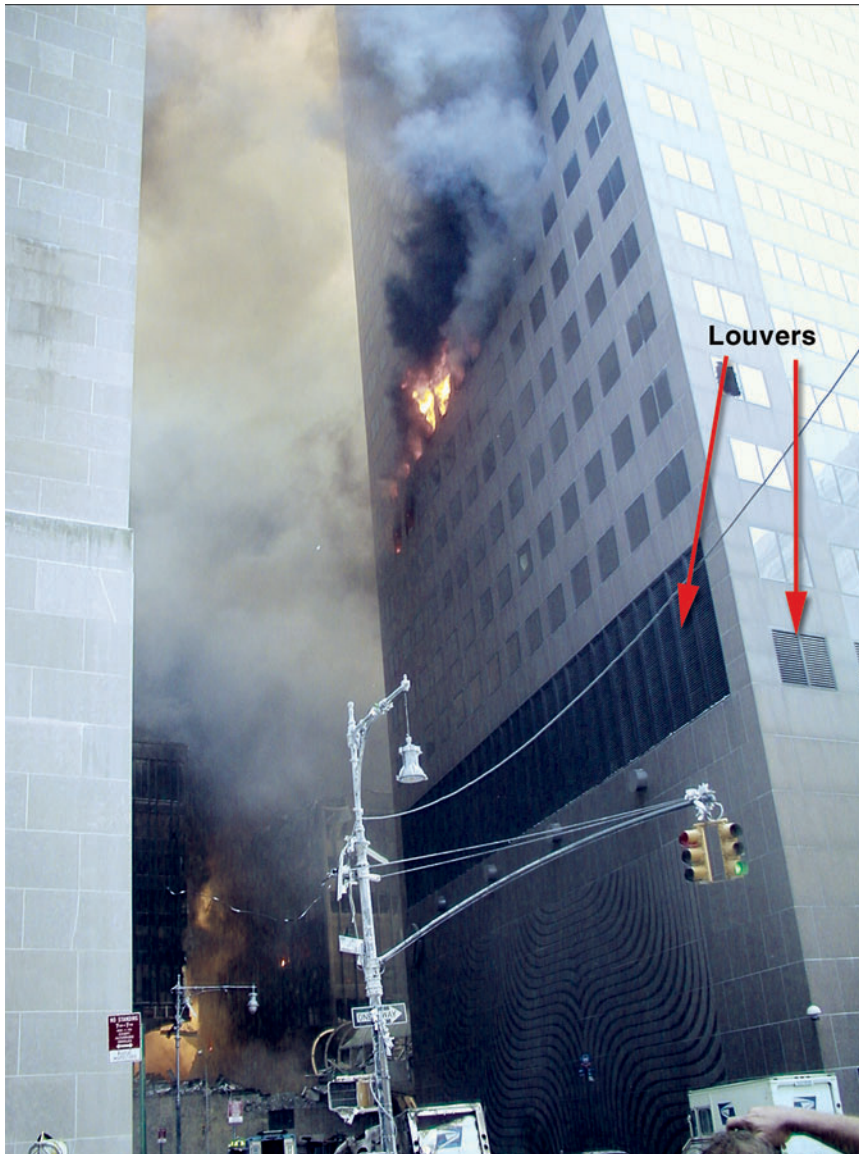
As the day progressed, fires were observed on the east face of the 11th, 12th, and 28th floors (see Figure 5-19). The Securities and Exchange Commission occupied floors 11 through 13. Prior to collapse, fire was seen to have broken out windows on at least the north and east faces of WTC 7 on some of the lower levels.

Figure 5-19
Fires on the 11th and 12th floors of
the east face of WTC 7.

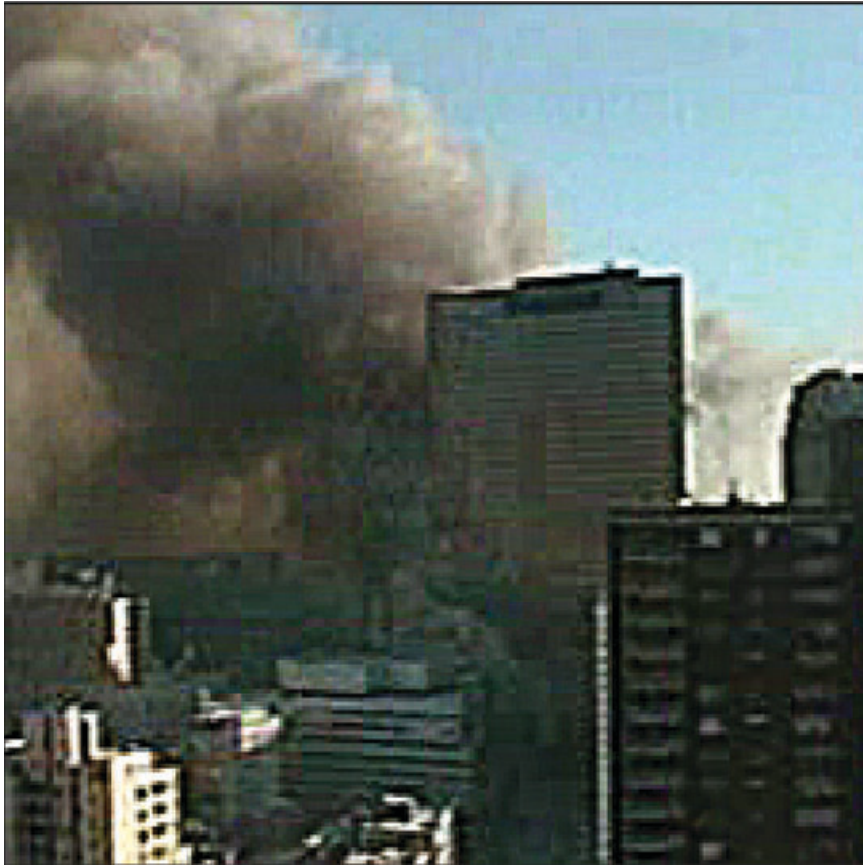
Figure 5-21
East mechanical penthouse collapsed.
(From video.)

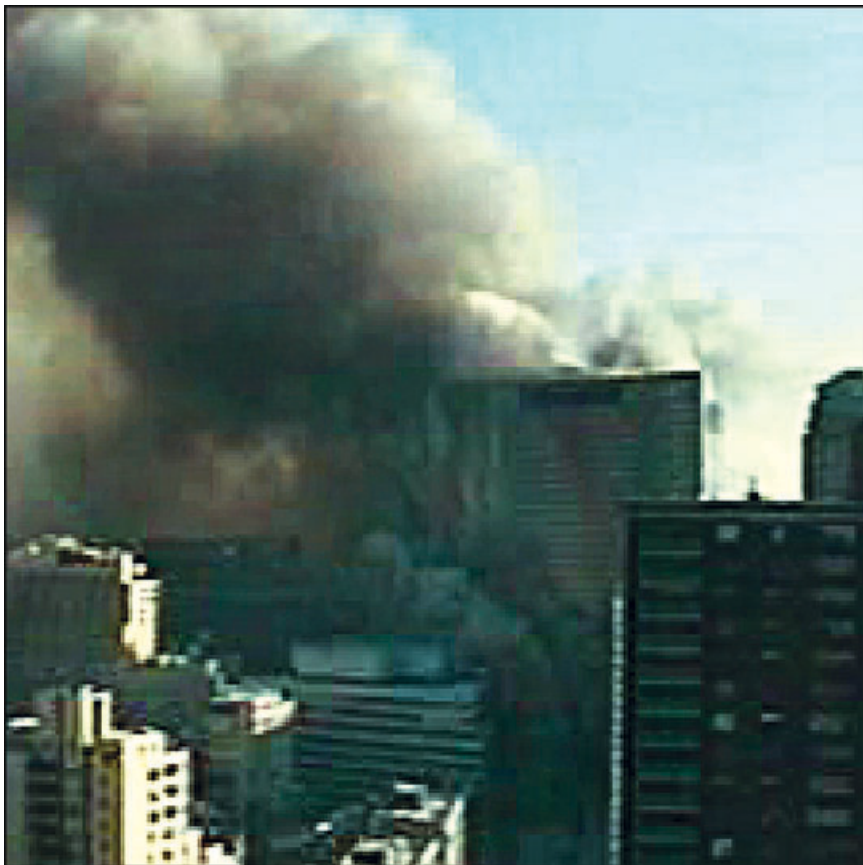
Figure 5-22
East and now west mechanical
penthouses gone. (From video.)

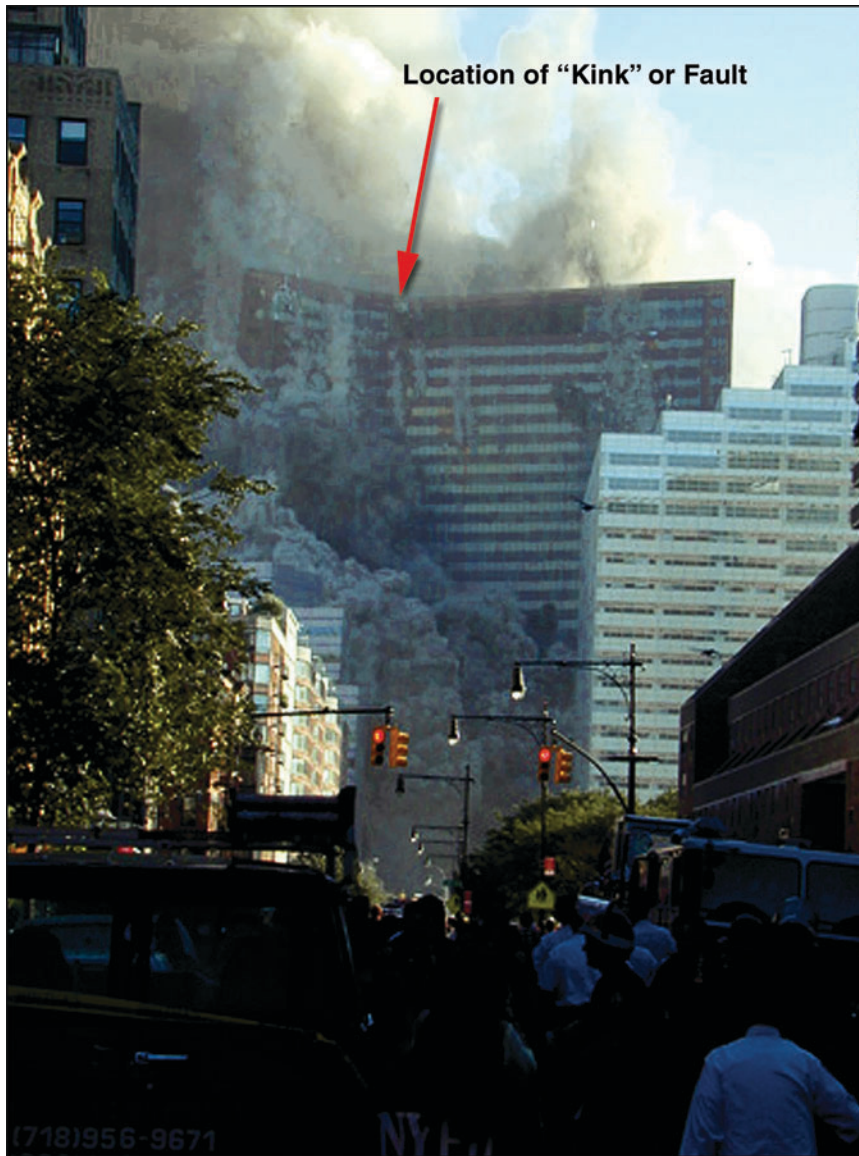
~5:21:09 p.m. Approximately 1 or 2 seconds after the west penthouse sinks into WTC 7, the whole building starts to collapse. A north-south “kink” or fault line develops along the eastern side as the building begins to come down at what appears to be the location of the collapse initiation (see Figures 5-23 and 5-24).

Figure 5-23
View from the north of the “kink” or fault developing in WTC 7.

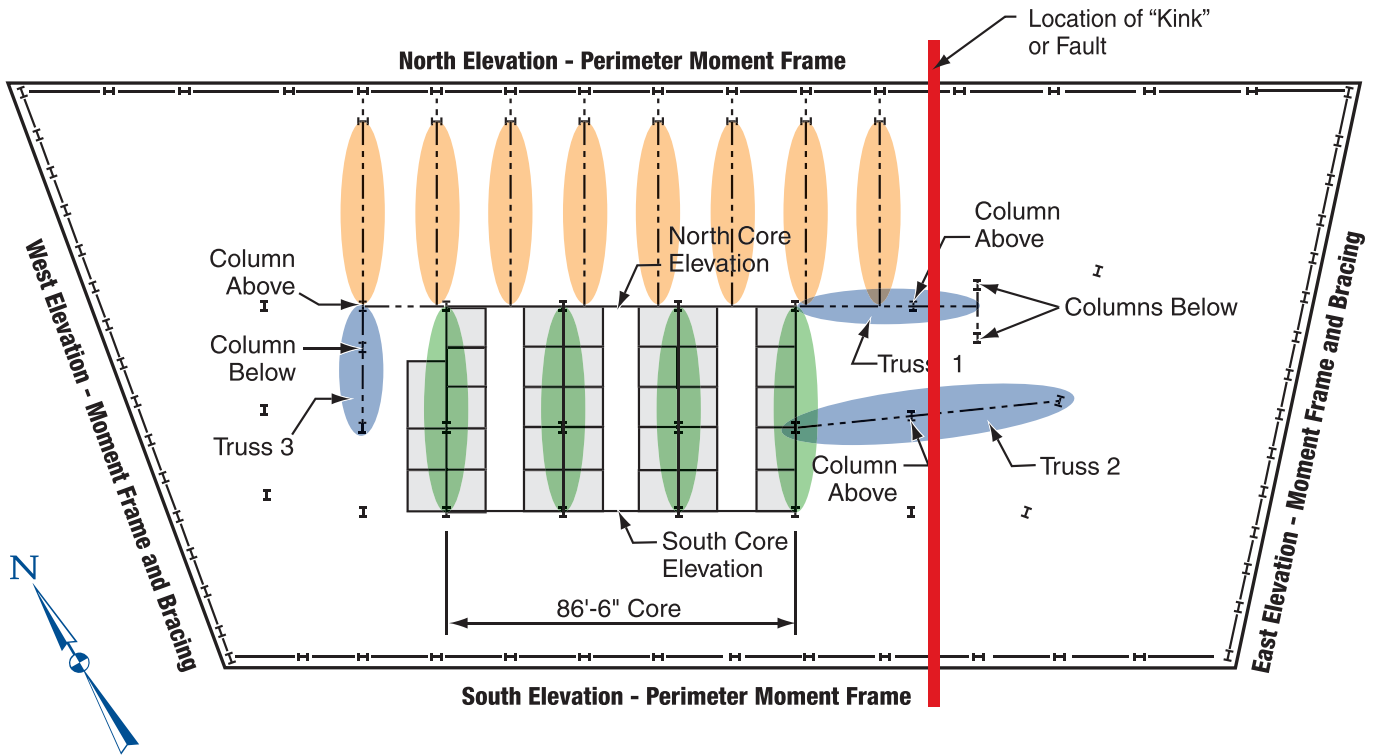
- Truss (Figures 5-7 Through 5-9)
- Eight Cantilever Transfer Girders (Figure 5-10)
- Four Transverse Core Elevations (Figure 5-3)
- Elevators

Figure 5-24 Areas of potential transfer truss failure.

5th Floor Scenarios. From a structural standpoint, the most likely event would have been the collapse of Truss 1 and/or Truss 2 located in the east end of the 5th and 6th floors. These floors are believed to have contained little if any fuel other than the diesel fuel for the emergency generators, making diesel oil a potential source of fire. As noted in Section 5.4, the fuel distribution system for the emergency generators pumped oil from tanks on the lower floors to the generators through a pipe distribution system. The SSB fuel oil system was a more likely source of fire around the transfer trusses. The SSB pump is reported as a positive displacement pump having a capacity of 75 gpm at 50 psi. Fuel oil was distributed through the 5th floor in a double-wall iron pipe. A portion of the piping ran in close proximity to Truss 1. However, there is no physical, photographic, or other evidence to substantiate or refute the discharge of fuel oil from the piping system.

rate (about 60 MW potential), the exposed members in the truss could still be subjected to high temperatures that would progressively weaken the steel. For the above reasons, it is felt that burning of discharged diesel fuel oil in a pool encompassing Truss 1 and/or Truss 2 needs to be further evaluated as a possible cause of the building collapse.

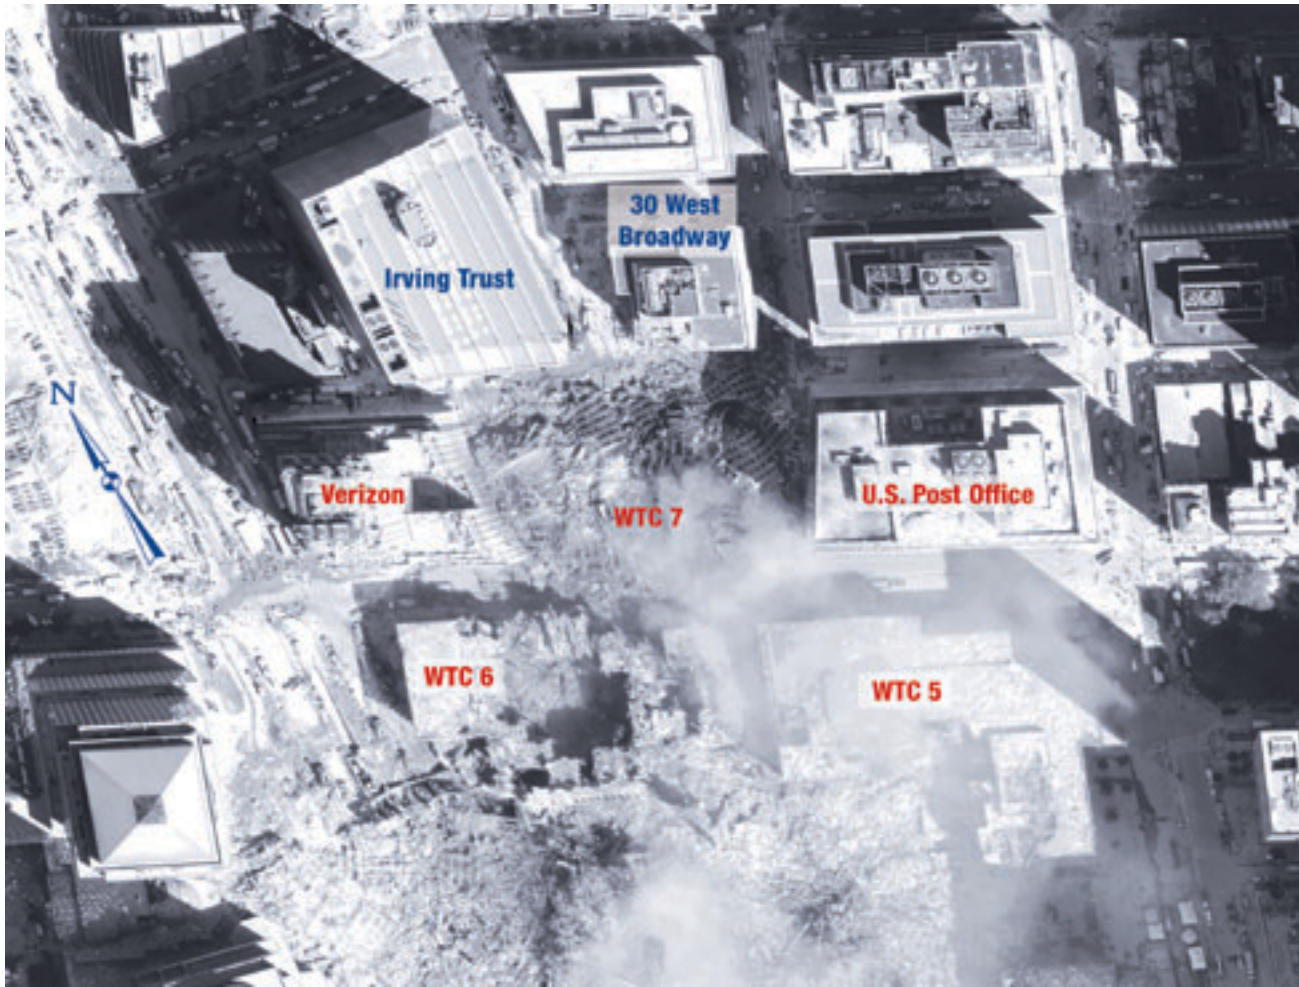
The debris generated by the collapse of WTC 7 spread mainly westward toward the Verizon building, and to the south. The debris significantly damaged 30 West Broadway to the north, but did not appear to have structurally damaged the Irving Trust building at 101 Barclay Street to the north or the Post Office at 90 Church Street to the east. The average debris field radius was approximately 70 feet. Figures 5-12(C) and 5-26 show an approximation of the extent of the debris after the collapse of WTC 7.

Figure 5-26 Debris generated after collapse of WTC 7.
